M-100 Repair Limits

E3844038-4 – Stator 1st Stage GTCP 331-200

Subject:	Braze repair of inner and outer band cracks
Extex Part Number(s):	E3844038-4 Stator 1 st Stage GTCP 331-200
Engine Application(s):	Honeywell GTCP 331-200 Series Auxiliary Power Unit (APU)
Compliance:	Any time the stator fails FPI on the inner or outer band and cannot be hand finished; it is to be repaired per the attached instructions.
Revisions:	N/C Dated: 09/27/10 Initial Release. A Dated: 02/12/16 Updated Timken to EXTEX Engineered Products.

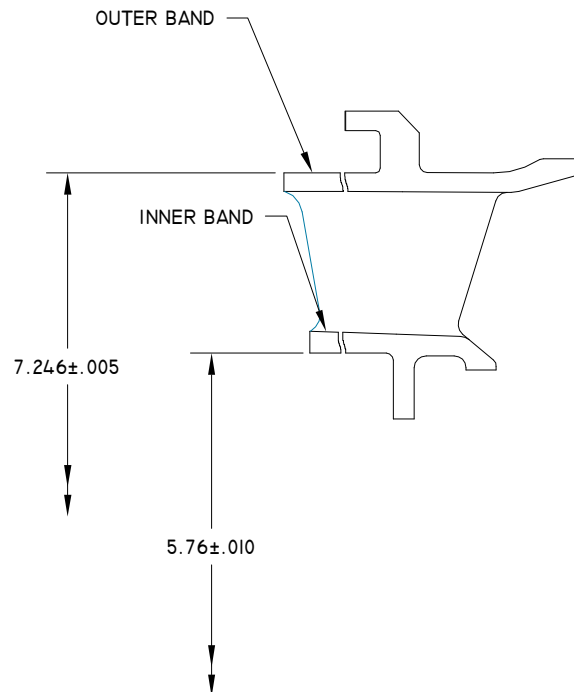
FIGURE 1

E3844038-4 Stator 1st Stage GTCP 331-200 has FPI indications on the inner or outer band which cannot be hand finished. Rounded indications and/or micro-cracks in cluster areas no greater than 40% of I.D. or O.D. of either band can be repaired per these instructions.

Instructions are provided for braze repair of inner and outer band cracks. Figure 1 depicts key features of the subject stators.

- Clean surfaces to be brazed
- Braze inner or outer band per AMS 2675 using AMS 4777 braze alloy
- Hand finish or machine to original dimensions (Figure 1)
- FPI per ASTM E 1417, Type 1, Method A or D, Sensitivity Level III. No indications permitted
- Dimensional inspection
