Inspection Limits & Repair T-010

Compressor Adapter Coupling

Engine Application(s):	A250-C20, C20B, C20F, C20J, C20S, C20W		
Compliance:	Any time the Compressor Adapter Coupling is removed for overhaul. Refer to the Table 1 and Figure 1 for Inspection and Rework Limits.		
	Table 1: Inspection and Rework Limits Figure 1: Dimensional Inspection Limits for A6898561/E6898561/EH6898561 Figure 2: Dimensional Inspection Limits for A23039791/E23039791/E23039791-1, -2, -3 EH23039791-1, -2, -3		
Notes:	Replaces Service Letter T94-013 issued by Superior Turbine on June 13, 1994. Refer to OEM's published data for installation, engine operation and disassembly.		
Revisions:	Rev. N/C	1/30/97	Original issue.
	Rev. A	1/14/99	Updated format, added P/N A23039791/E23039791/E23039791-1, -2, -3, EH23039791-1,-2,-3
	Rev. B	1/20/01	Added P/N EH6898561.
	Rev. C	8/21/03	ECO# 1361: REVISE PAGE 4 FRETTING INSPECTION NOTE.
	Rev. D	2/02/16	Revised to EXTEX Engineered Products.

P/N(s): **A23039791, E23039791
 A6898561, E6898561
 E23039791-1, -2, -3
 EH23039791-1,-2,-3
 EH6898561**

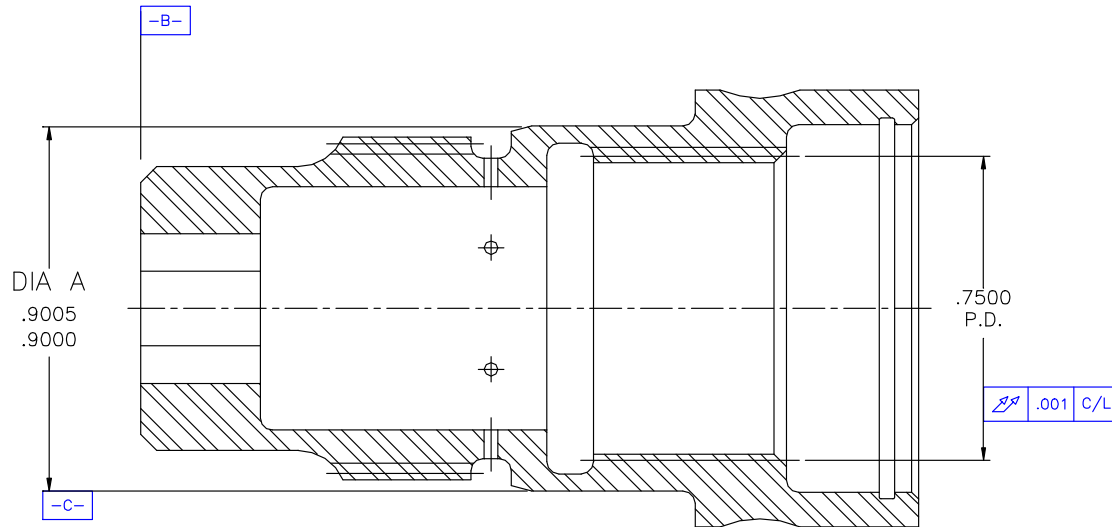
FIGURE 1
A23039791/E23039791
E23039791-1, -2, -3/EH23039791-1,-2,-3
Compressor Adapter Coupling Dimensional Inspection

P/N	DIA
A23039791	.9000-.9005
E23039791	.9000-.9005
E23039791-1	.9000-.9005
E23039791-2	.9020-.9025
E23039791-3	.9040-.9045
EH23039791-1	.9000-.9005
EH23039791-2	.9020-.9025
EH23039791-3	.9040-.9045

- CENTERLINE -CL- IS DEFINED BY SURFACES -B- AND -C-.
- IF UNACCEPTABLE WEAR IS FOUND ON COUPLING ADAPTER OR SPUR ADAPTER GEARSHAFT, REPLACE BOTH PARTS AS A SET.
- WHEN THE COUPLING ADAPTER IS REPLACED DUE TO SPLINE WEAR, THE ROTOR DOES NOT REQUIRE REBALANCING. PD RUNOUT CHECK MUST BE PERFORMED.
- DIMENSIONS ARE IN INCHES.
- INSPECT THE OD FOR FRETTING. IF ANY FRETTING IS FOUND, REPLACE THE ADAPTER AND SEND THE FRETTED ADAPTER TO EXTEX, Ltd. FOR EVALUATION.

- MEASURE (2 PLACES, 90° APART) AND RECORD DIAMETER. ENSURE THAT WHEN ADAPTER IS ASSEMBLED INTO IMPELLER WITH NO.2 BEARING REMOVED, THE RESULTING FIT IS .000 TO .0015 TIGHT.
