T-015 Inspection Limits and Repair

Revision: F Issued: 2/02/16

P.T. Outer Shaft

Engine Application(s):	Allison 250-B17, B17B, B17C, B17D, B17E, B17F, B17F/1, B17F/2; 250-C20, C20B, C20F, C20J, C20R, C20R/1, C20R/2, C20R/4, C20S, C20W; 250-C22B.																					
Compliance:	Any time the PT Outer Shaft is removed for engine overhaul, it should be inspected to Extex criteria. The inspection will determine if the component is serviceable in its current condition, if the component is repairable per this instruction or if the component should be replaced.																					
Notes:	Replaces Service Letter T95-002 issued by Superior Turbine on April 1, 1995. Refer to Type Certificate Holder's published data for installation, engine operation, and disassembly. EH23037413 added 9/8/98. The "H" denotes High Strength Tool Steel. Otherwise, it is identical to E23037413.																					
Revisions:

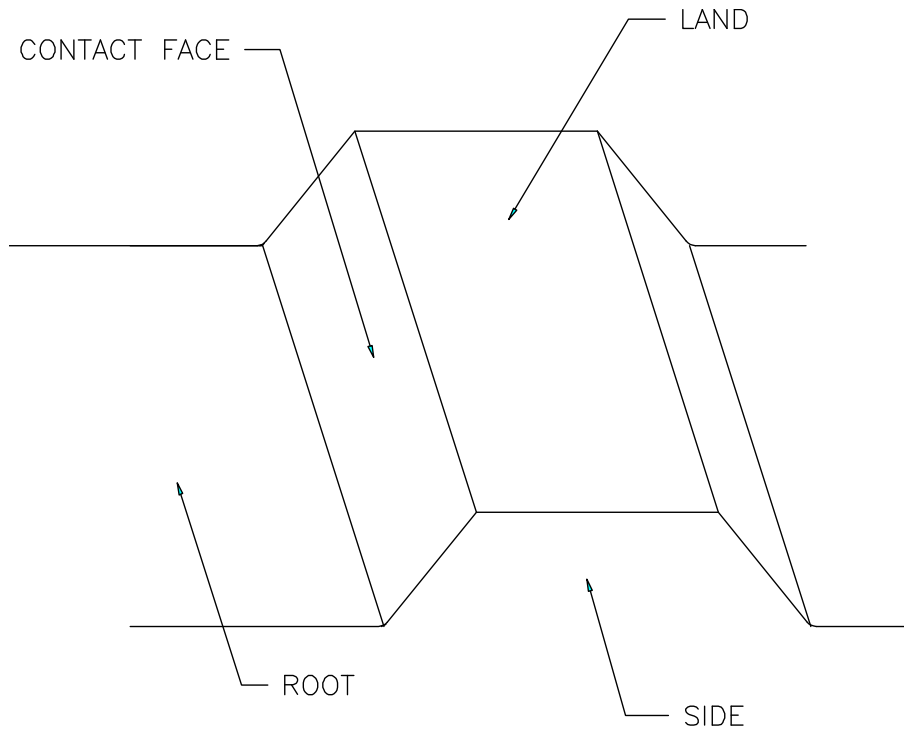
FIGURE 1

Condition	Service Limit	Repair Limit	Corrective Action
Cracks, visual and MPI*	Cracks are not acceptable.	No Repair.	Replace.
Imperfections in the Curvic Coupling	See Figure 1.	No Repair.	Replace.
Bearing Journal Wear	See Figure 2.	1.573 Dia.	Grind journal diameter to prepare surface. Build up diameter with Nickel Plate per MIL-C-26074 or AMS 2404 or Chrome Plate per AMS 2406. Grind per Figure 2.
Wear on 1.0410 I.D.	See Figure 2.	1.0415 Dia.	Grind diameter to prepare surface. Build up diameter with Nickel Plate per MIL-C-26074 or AMS 2404 or Chrome Plate per AMS 2406. Grind per Figure 2.
Loss of Plating	Loss of plating coverage is not acceptable.	Any amount of plating coverage loss.	Re-plate per Figure 2 OR Replace.

FPI	MAX SIZE	MIN SEPARATION	LIMITATIONS
INDIVIDUAL INDICATIONS	0.020 INCH	2X	NOT OVER EDGE
CLUSTER INDICATIONS	NONE PERMITTED

VISUAL (INSPECT WITH 10x MAGNIFICATION OR GREATER.)

POSITIVE IMPERFECTION:

NONE ALLOWED ON CONTACT FACE, ROOT, LAND (SEE ILLUSTRATION).
FOLLOW REWORK PROCEDURES FOR HIGH METAL REMOVAL. 0.010 IN.
IS ALLOWED ON SIDES IF IMPERFECTION IS SMOOTH AND ADHERENT.

NEGATIVE IMPERFECTION:

CONTACT FACE, SIDES AND LANDS - 0.030 IN. DEEP OR LESS ON NO
MORE THAN 25% OF THE SURFACE AREA ON NO MORE THAN FOUR
TEETH. DAMAGED AND REWORKED TEETH MUST BE SEPARATED BY AT
LEAST ONE UNDAMAGED TOOTH.

ROOT:

NONE ALLOWED.

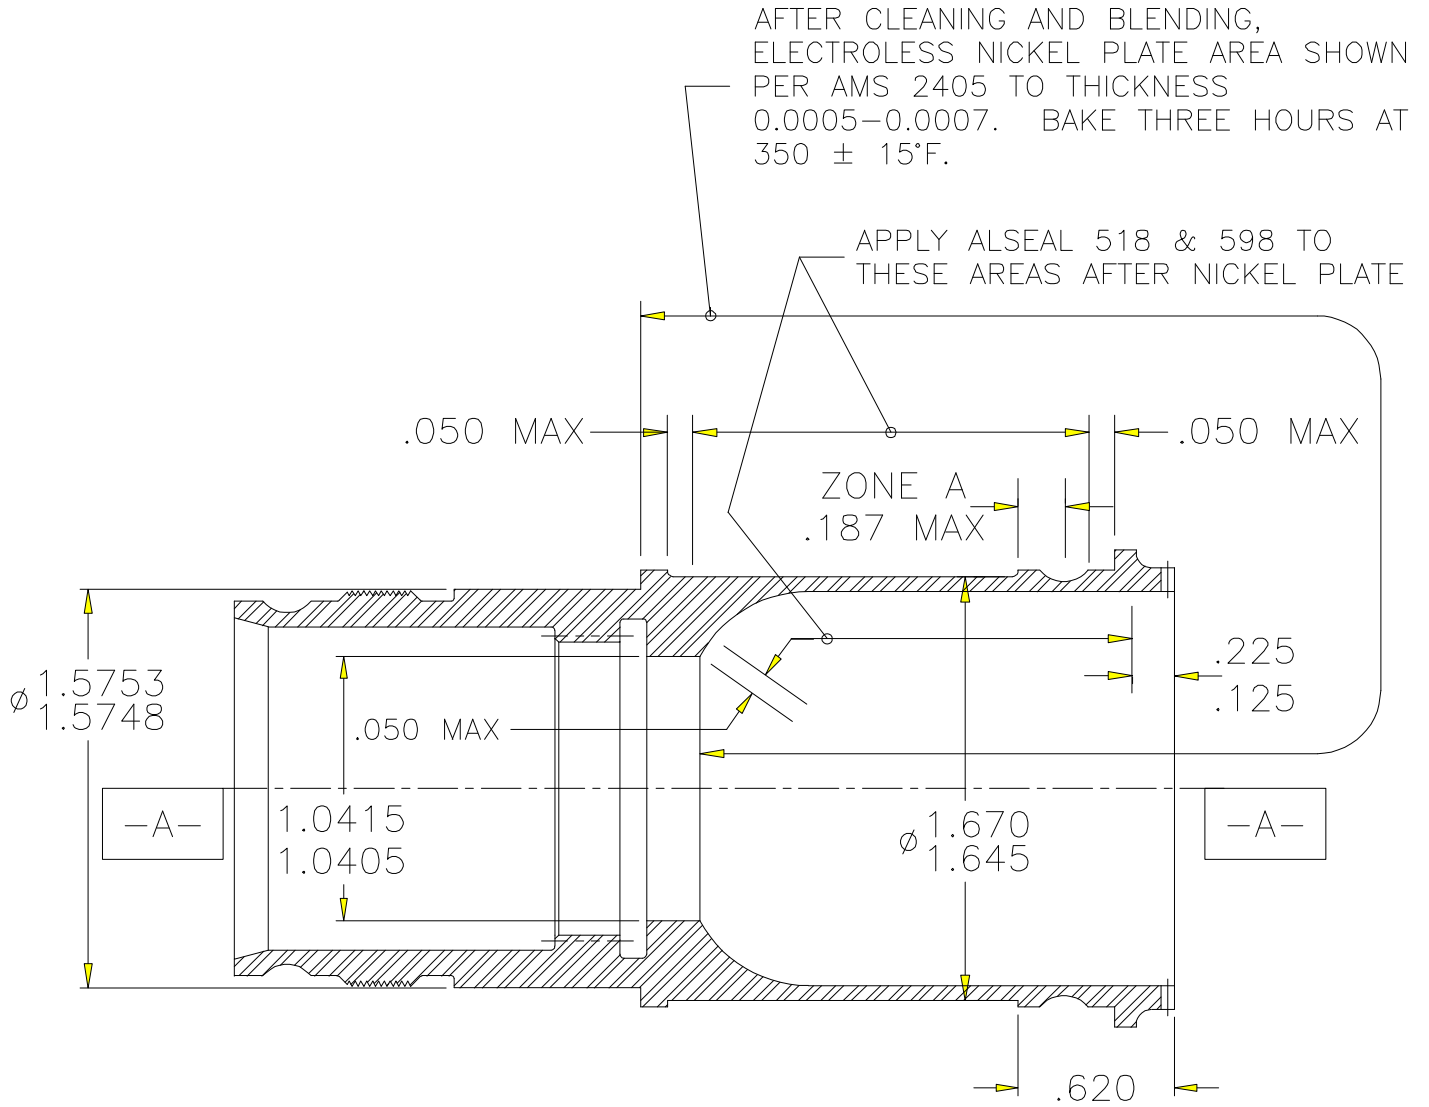
FIGURE 2

Scratches on the coated safety flange are acceptable if:

- (1) Scratches are in zone A (See Figure 2).
- (2) Nickel plating under the scratch is not damaged.

3.0 Apply electroless nickel plating, as shown in Figure 2, to the shafts that have passed the inspection criteria and are considered serviceable.

4.0 Apply Alseal 518 & 598 coating over the electroless nickel plating in areas shown in Figure 2 except for:
