## T-033 Inspection Limits and Repair

Revision: E

### 2<sup>nd</sup> Stage Turbine Splined Adapter

**Subject:** Inspection and Rework Procedures for the E23030974, EH23030974 & E23076529 2<sup>nd</sup> Stage Turbine Splined Adapter.

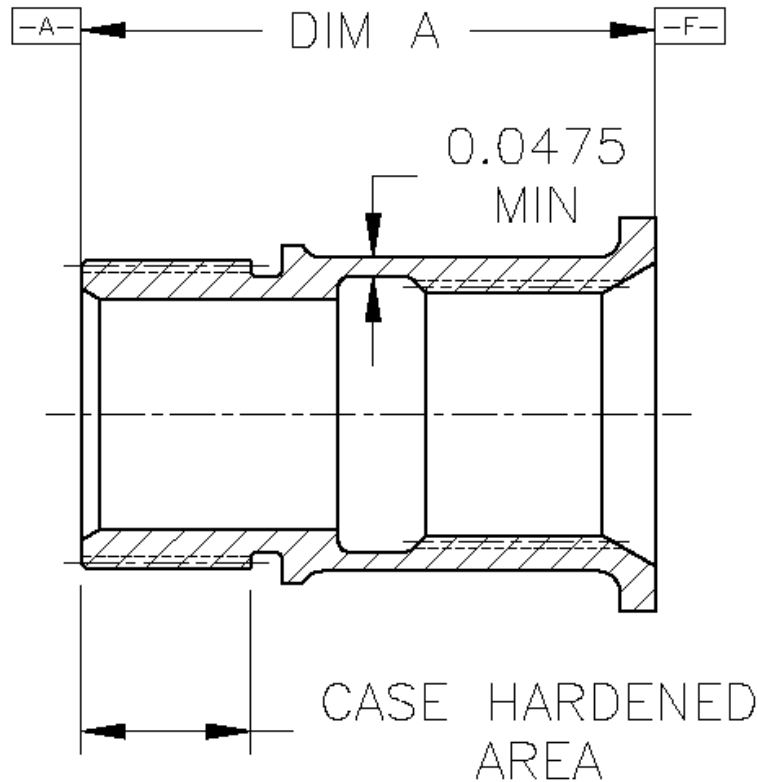
FIGURE 1

Dimensional Inspection (Pilot Diameter "A" and Pitch Diameter Run Out)	Check for compliance with Figure 1.	No Repair.	Install new or serviceable Splined adapter if Service Limit is exceeded.
Hardness check *** (over temperature inspection)	Hardness check must be made on OD. Hardness of 15N-79.5-81.5. See Figure 1.	No Repair.	Replace, if hardness is below limit minimum.
Wall thickness forward of internal splines (at internal spline relief). See Fig. 2.	0.0475 inch.	No Repair.	Install new or serviceable Coupling Adapter if Service Limit is exceeded.

Surface A must be parallel to surface F within 0.0005.
