T-051 SERVICE BULLETIN

Inspection and Rework of A/E23037403, E23038137 Power Turbine Inner Shafts

Engine Application(s): Allison 250-C20, C30 Series

Subject: Inspection, rework instructions for Power Turbine inner shafts to enhance atmospheric corrosion protection.

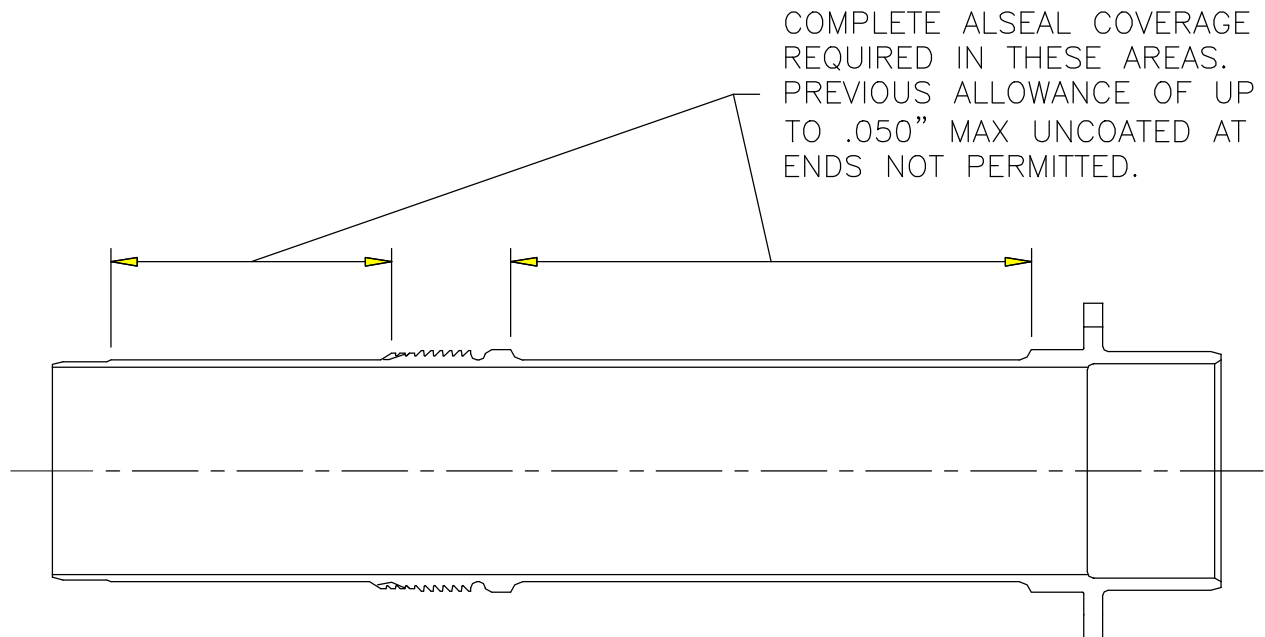
FIGURE 1

1.1 Inspect Aseal coating in accordance with Figure 1.

1.2.1 If part is not in compliance with Figure 1, but there is no corrosion evident, obliterate old part number and mark with new part number as indicated below per AS478-3B1 (manual Vibropeen) followed by T-051.

1.2 If in compliance, obliterate old part number and mark with new part number as indicated below per AS478-3B1 (manual vibropeen).

- 2.2 If strip and recoat is not necessary per the applicable ILR, and the existing Aseal coating complies with Figure 1, obliterate old part number and mark with new part number as indicated in 1.2 per AS478-3B1 (manual vibropeen).

- 2.3 If strip and recoat is necessary, process per the applicable ILR instructions with Aseal in accordance with Figure 1 of this service bulletin. Obliterate old part number and mark with new part number as indicated in 1.2 per AS478-3B1 (manual vibropeen),
