T-083 Inspection Limits and Repair

Stationary/Rotating No. 5 Labyrinth Seals

Engine Application(s):	250-C28B, C28C 250-C30, C30L, C30M, C30P, C30S 250-C30R, C30R/3, C30U, C30G 250-C30G/2, C30R/1 250-C40B 250-C47B, C47M		
Subject:	Inspection and Rework Procedure for No. 5 Labyrinth Seals: E23032327 & E23032328.		
Compliance:	Any time the No. 5 Labyrinth Seal is removed. Refer to the Table for Inspection and Rework Limits.		
Notes:	Refer to OEM's published data for installation, engine operation and disassembly.		
Revisions:	N/C	Dated: 2/15/05	Initial Release.
	A	Dated: 8/13/09	Updated EXTEX to TIMKEN.
	B	Dated: 2/05/16	Updated Timken to EXTEX Engineered Products.

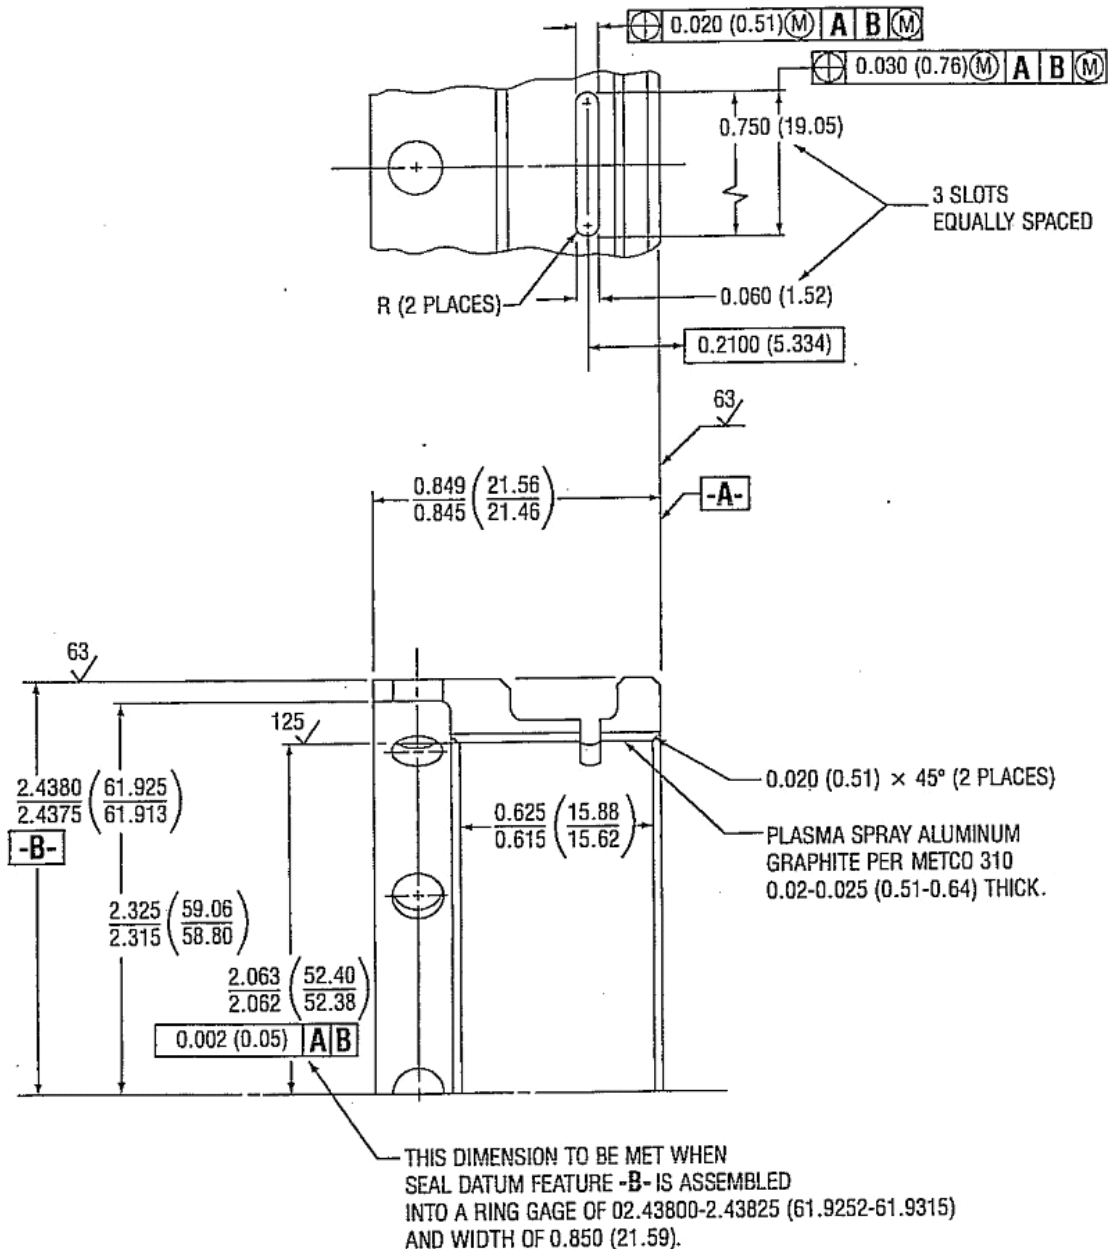
FIGURE 1

Condition	Service Limit	Repair Limit	Corrective Action
Nicks, scratches, or damage to silver seal surface	Desired radial seal clearance with mating part	Damage to parent metal	Replace aluminum graphite in accordance with Figure 1.
Fit of seal in bore	.0005-.002 in. tight		Repair or replace.

- * Maintain .001 in. FIR concentricity about center axis of wheel blade tip or seal knife edge features if reworked.
- ** Remove burrs on wheel blade tip or seal knife edge but do not break sharp edges if reworked.
