T-037 Inspection Limits and Repair

**A6898784/E6898784/EH6898784
Turbine Splined Adapter
Inspection and Rework Limits**

**A6898784/E6898784/EH6898784
Second Stage Turbine Splined Adapter Inspection**

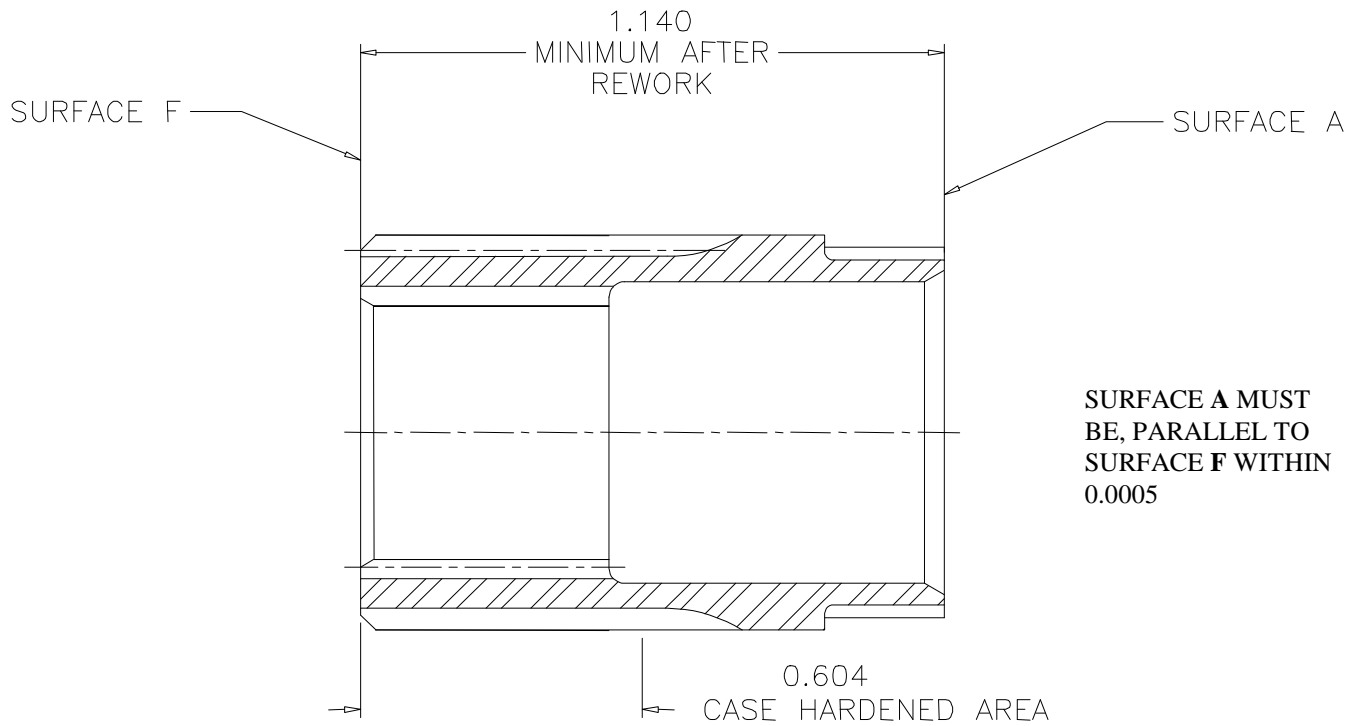
FIGURE 1

Condition	Service Limit	Repair Limit	Corrective Action
Dimensional Inspection (Pilot Diameter "A" and Pitch Diameter Run Out)	Check for compliance with Figure 1.	No Repair.	Install new or serviceable Splined adapter if Service Limit is exceeded.
Hardness check (over-temperature inspection)****	Hardness check must be made on the top flat of a spine which has been case hardened. Strip silver from selected area and check hardness. Min. hardness of 15N-92. See Figure 1.	No Repair.	Replace, if hardness is below limit minimum. Replate*****, if hardness is above limit minimum.
Wear on surface A	See Figure 1.	No Repair.	Re-qualify by grinding or lapping surface A.
