T-033 Inspection Limits and Repair

Revision: F

2nd Stage Turbine Splined Adapter

Subject: Inspection and Rework Procedures for the E23030974, EH23030974 & E23076529 2nd Stage Turbine Splined Adapter.

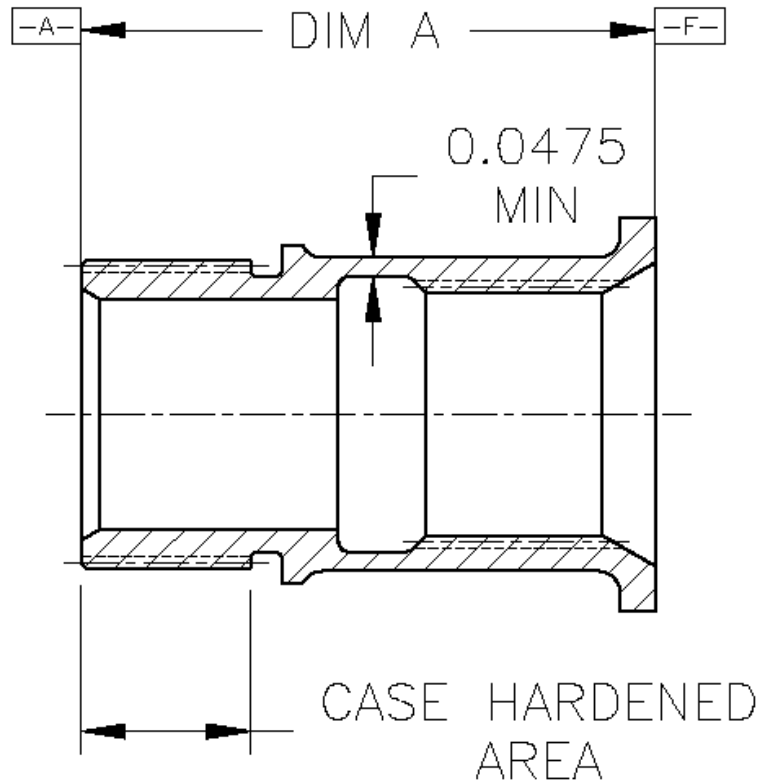
FIGURE 1

Dimensional Inspection (Pilot Diameter "A" and Pitch Diameter Run Out)	Check for compliance with Figure 1.	No Repair.	Install new or serviceable Splined adapter if Service Limit is exceeded.
Hardness check *** (over temperature inspection)	Hardness check must be made on OD. Hardness of 15N-79.5-81.5. E23076529: 15N-77.0 MIN. See Figure 1.	No Repair.	Replace, if hardness is below limit minimum.
Wall thickness forward of internal splines (at internal spline relief). See Fig. 2.	0.0475 inch.	No Repair.	Install new or serviceable Coupling Adapter if Service Limit is exceeded.

Surface A must be parallel to surface F within 0.0005.

Table 2 - Dimension A	
E23076529	1.930/1.950
E23030974	1.620/1.640
