T-815 Service Bulletin

| Subject: | Compressor Turbine (CT) Blade |
| EXTEX Part Numbers: | E3045741-01 revision D (or prior) |
| Installation(s): | Pratt and Whitney Canada PT6A-11, -11AG, -15AG, -21, -25, -25A, -27, -28, -110, -112, -121 |

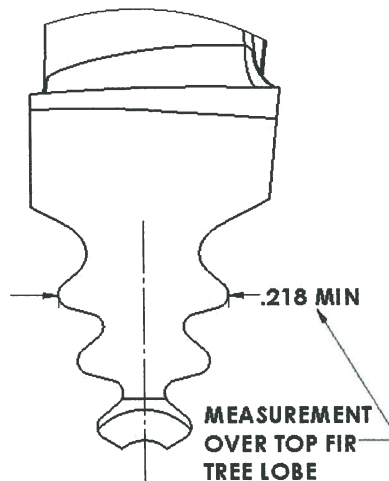
Figure 1

| Reason: | To provide Supplemental Instructions for Continued Airworthiness (ICA). EXTEX has identified blades in which the firtree external radii may be undersized. This condition has prompted EXTEX to require inspection and removal of undersized blades. |

| Accomplishment Instructions: | When blades are removed from disk, measure over the top lobes as shown in Figure 1. Scrap any blades that measure less than 0.218 inch. Record compliance with this service bulletin indicating inspection or removal in the applicable section of the engine log book. The entry should include the part number and a reference to EXTEX SB T-815. |
